# Seltún and its vicinity on Reykjanes peninsula in Iceland

A visual reflection on land condition and necessary improvements

Andrés Arnalds  
maí 2016

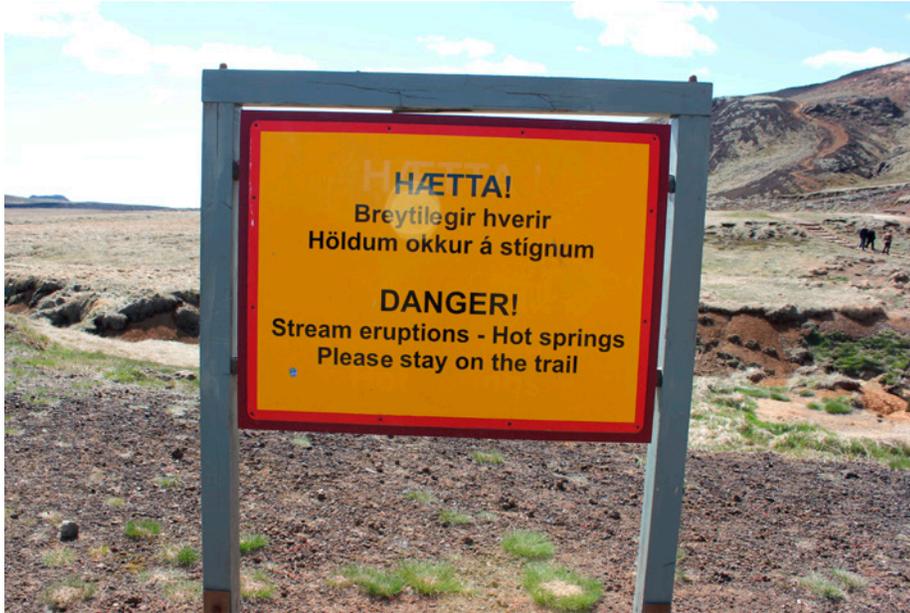
There is very little on-site guidance discouraging people from venturing off marked paths, and if so only in relation to danger from hot springs or geysers. Due to the extreme vulnerability of the area, it is important that people be explicitly forbidden to stray from the paths. Explanation is needed, showing visual examples of damage due to walking outside the paths.

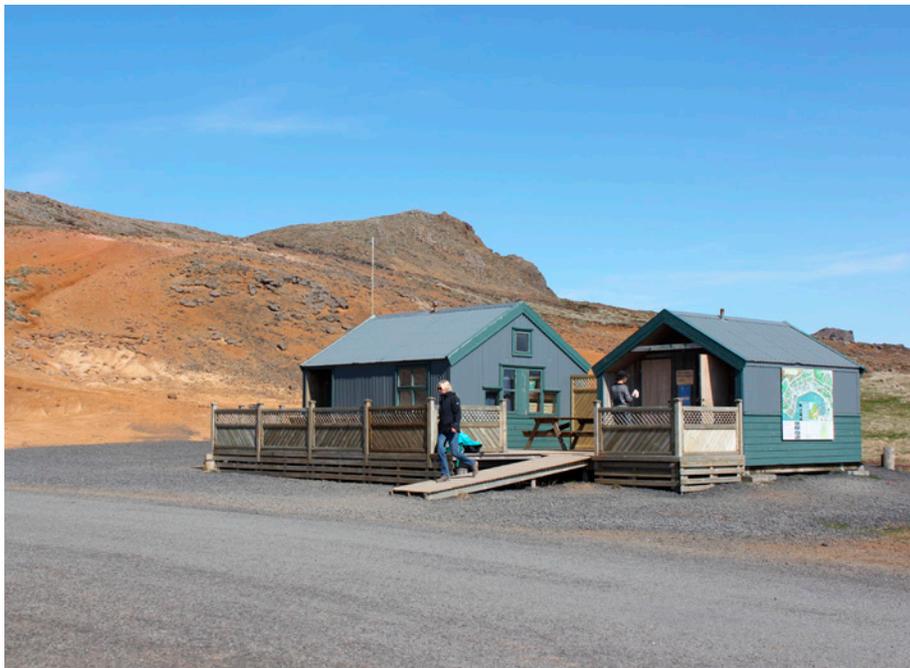
The facilities are in no way satisfactory for the large number of tourists that visit Seltún. For instance there are only two toilets, and they are closed during winter. The buildings are too close to the geothermal area itself, distracting from the visual whole of the area.

There are underutilised possibilities for providing information. For instance a large map of Hafnarfjörður city hangs on the toilet wall, but there is no outline map of the geothermal area itself, nor are there clear words of warning on the importance of nature preservation.

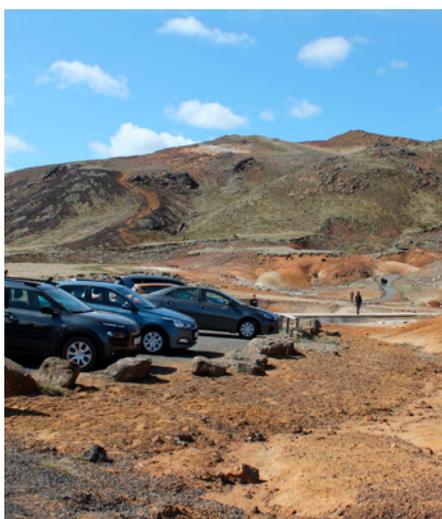
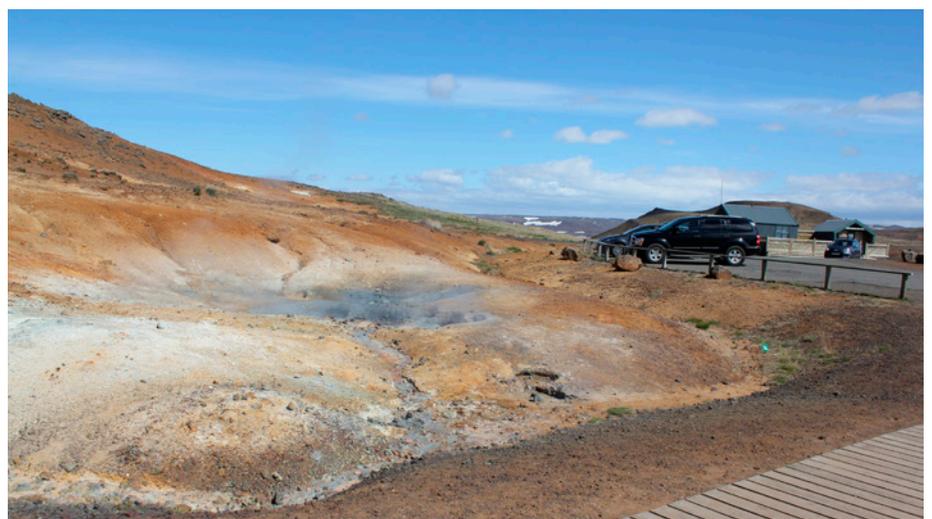
It seems to be a natural law in Iceland that cars should be parked almost on top of the natural wonders themselves. This sort of conduct destroys the visual beauty of the sites and creates unnecessary disturbance. The inner part of the car parking area should be closed. The car parking areas are being enlarged with a new parking area being constructed nearby. Should the toilets perhaps be moved to this new parking area?

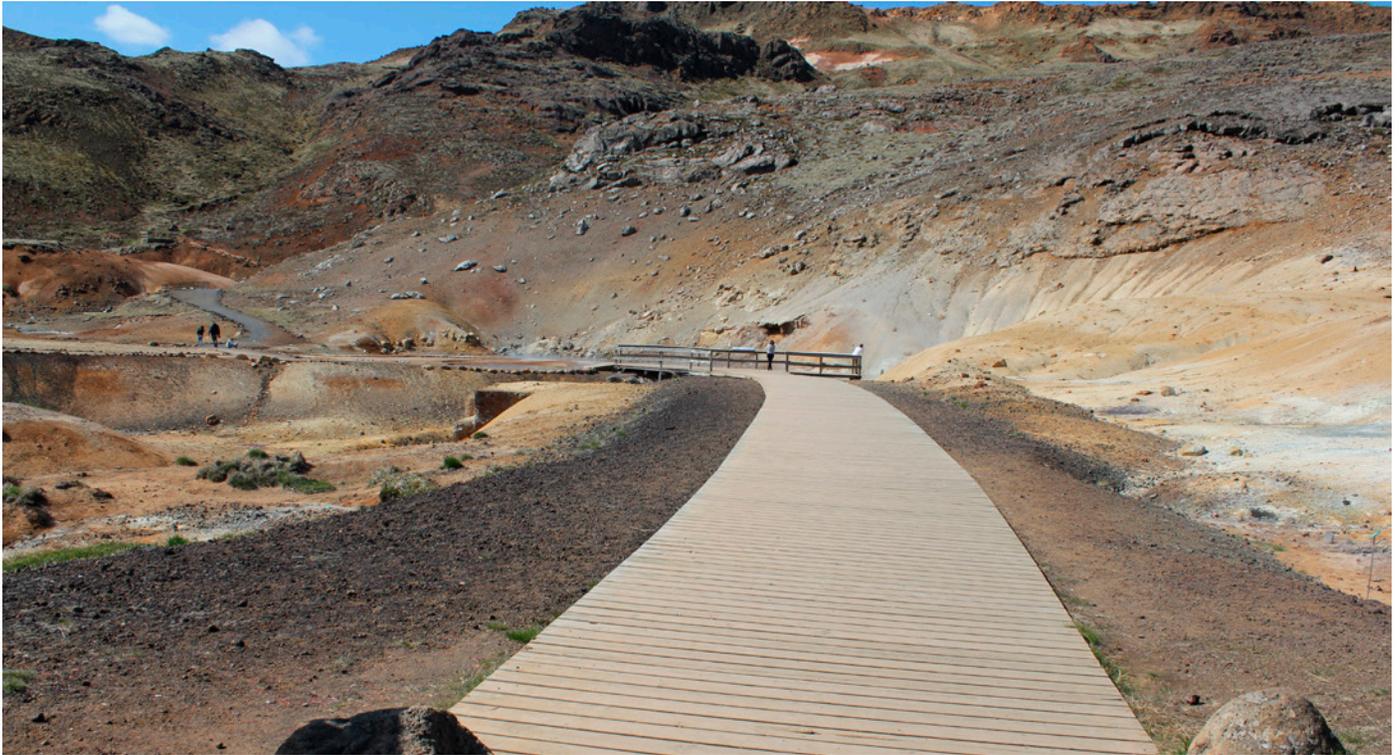
Here in Iceland board walkways seem to be the trendy option. Could the path to the geothermal area be better adjusted to the surroundings? How about the selection of colours and materials? The beginning of the hiking path does not seem natural enough.

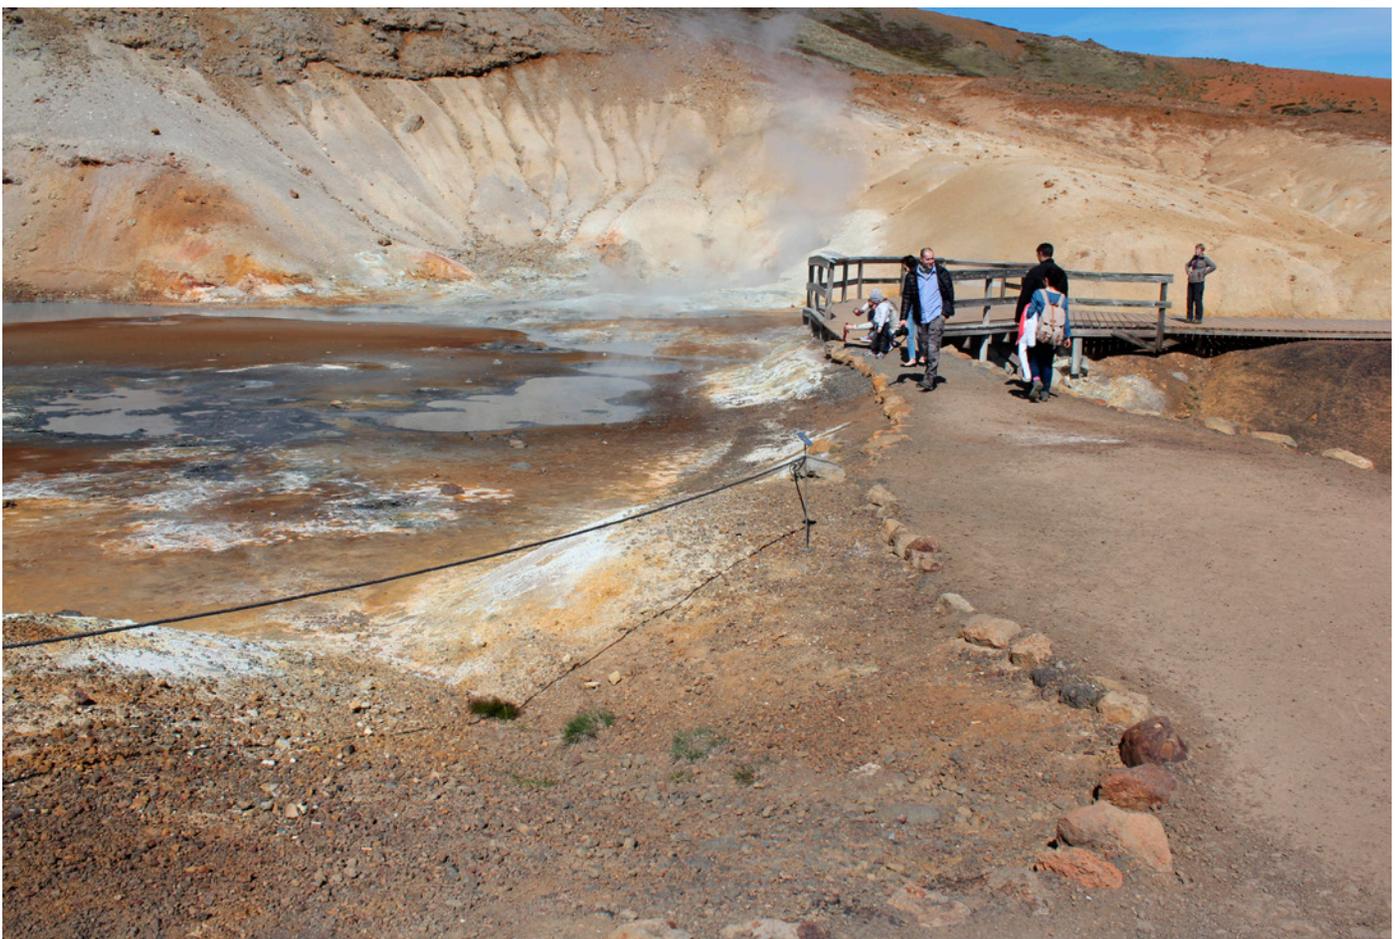
The hiking paths are weakly demarcated. Borders of access often lie too close to the hot springs themselves and open spaces seem to indicate that it is OK to venture off the path.

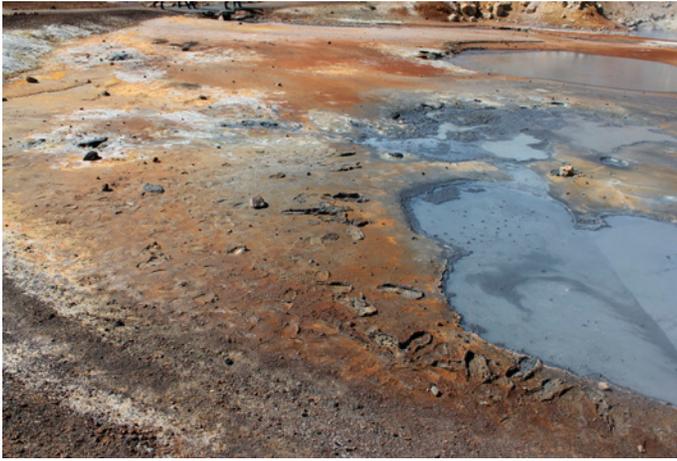
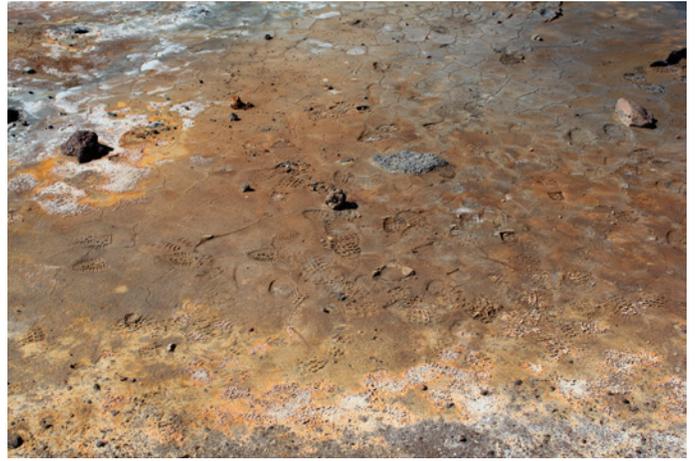
The result is extreme damage. The entire area, from the first hot springs and up to the hills, is deteriorating. There is a lot of damage due to walking outside the paths, which diminishes the pristine beauty of this colourful area.

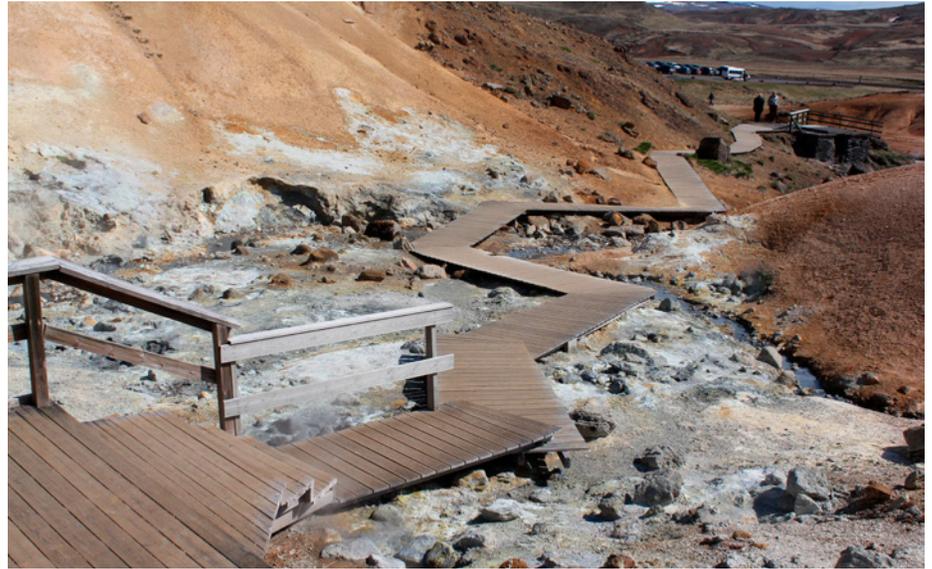
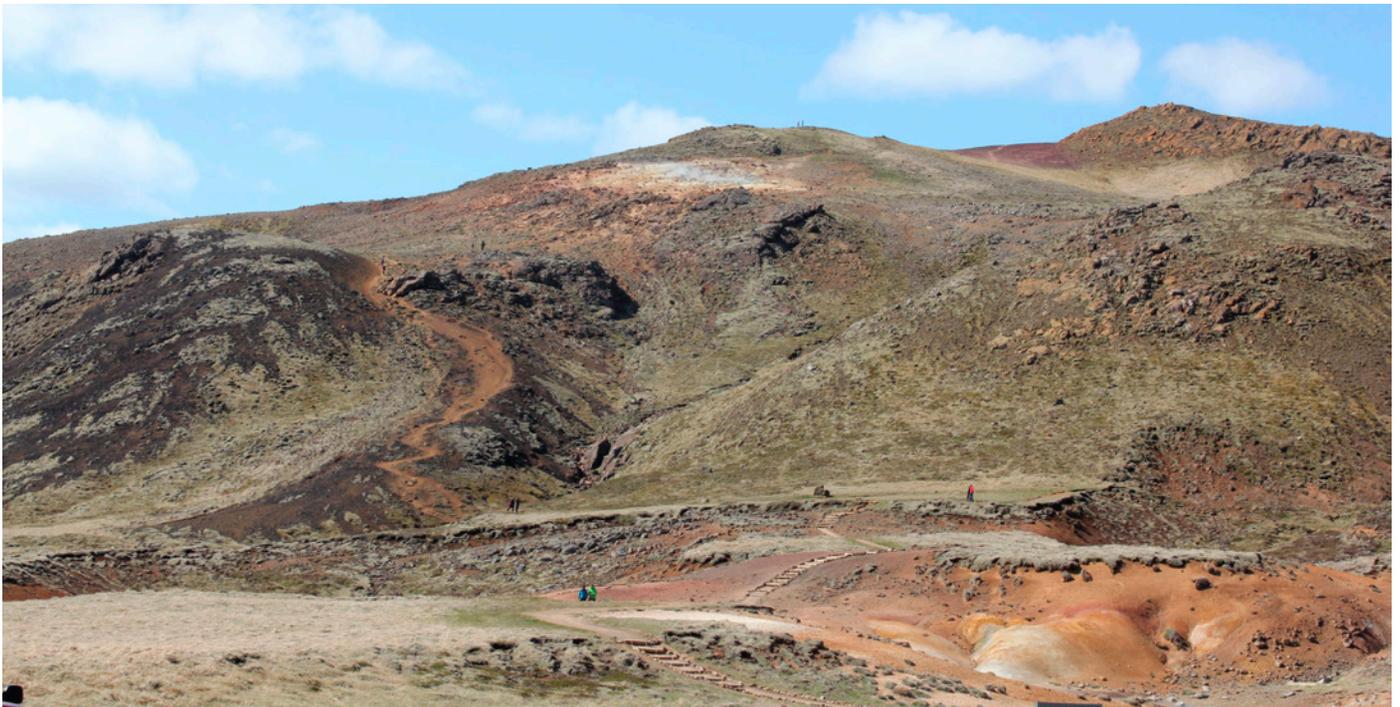
In the space of a few year, the number of those walking to the upper geyser-areas has multiplied, diminishing the beauty of the areas and forming an ever increasing number of trails. Little has been done to protect these areas. Actions to improve the situation underline the vital importance of increasing scientific and practical knowledge on how to construct paths, from the design stage to construction.

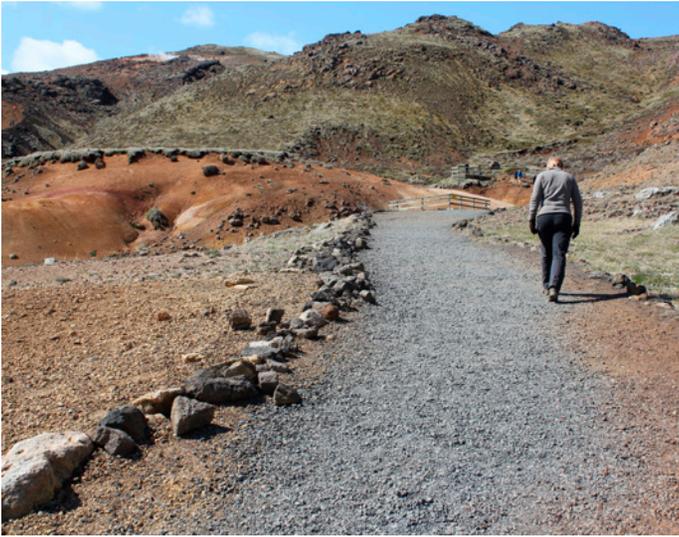
In this location, the gravel is too coarse for easy walking. In addition, the path is demarcated with rocks on both sides. This is a mistake, as it turns the path into a waterway during rainfall.

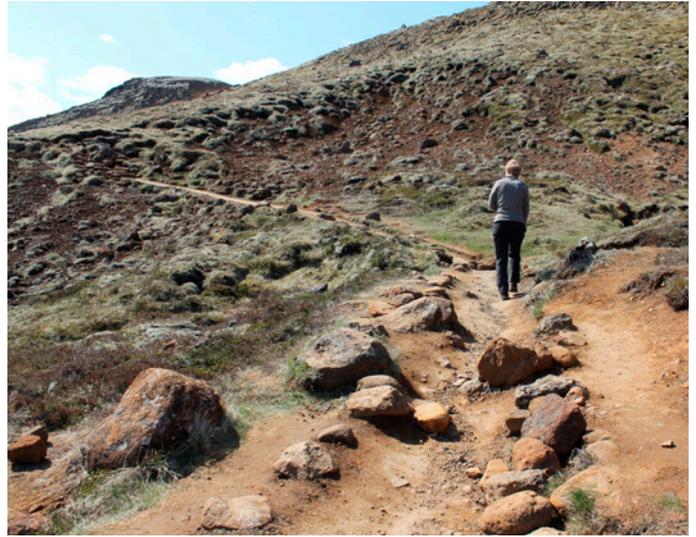
Here the path-building has gone awry. In this case, the main culprit is not strain from hikers, but water erosion and lack of maintenance.

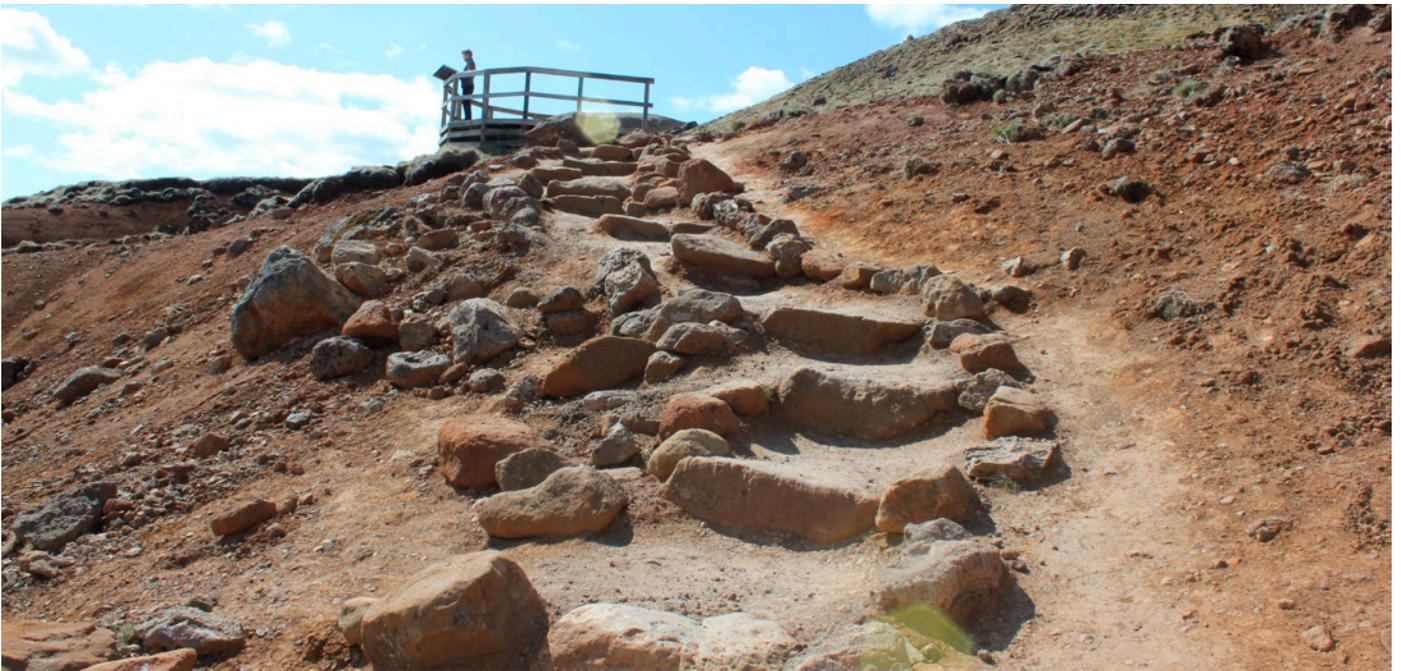
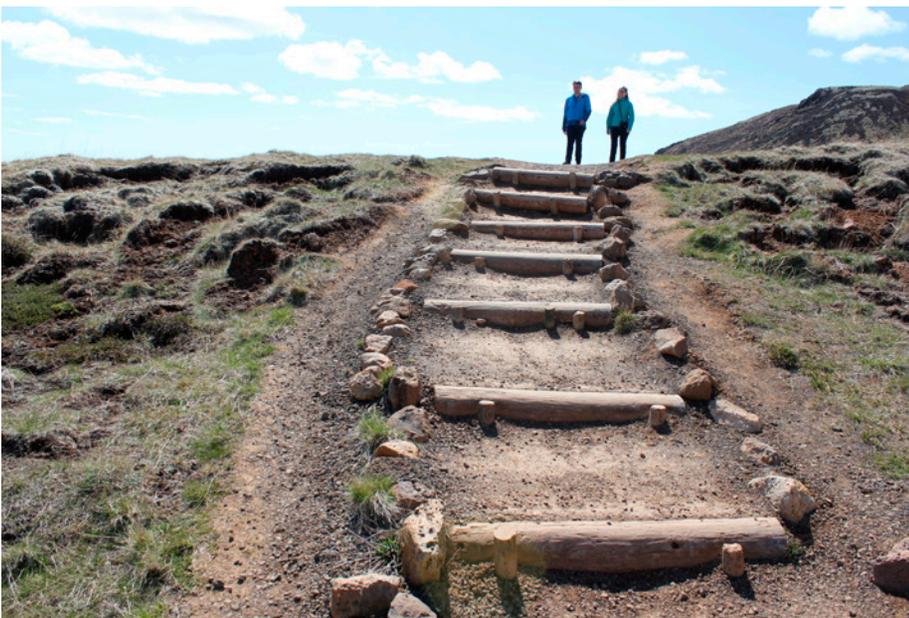
Without efficient action to divert waterflow from paths, the durability of steps and other structures to ease access and protect the soil is severely diminished. Additionally this multiplies maintenance cost.

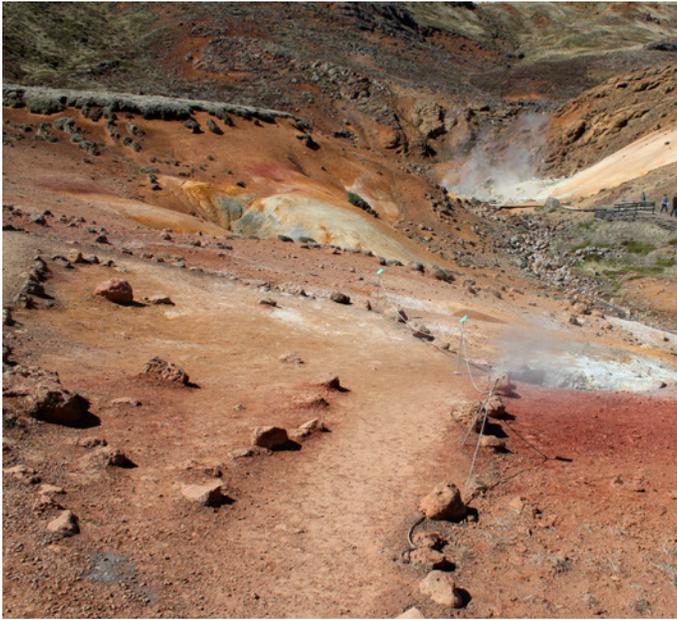
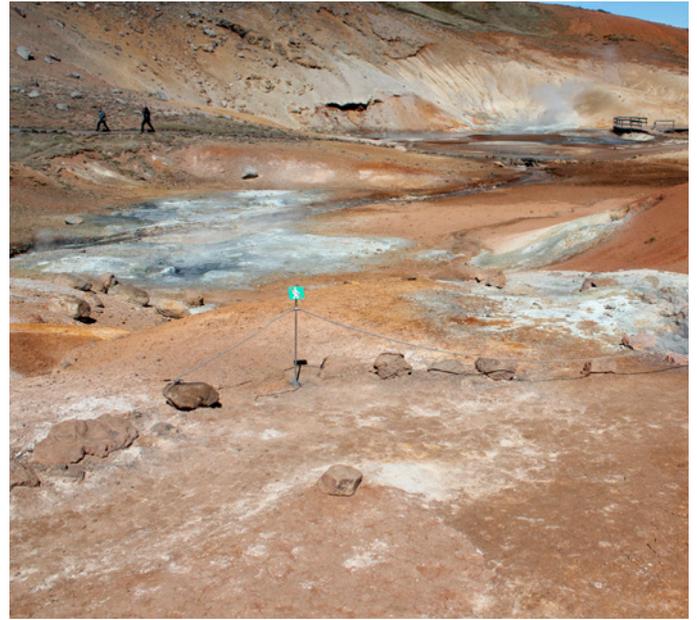
These pictures are in many ways typical for the consequences of the financial straits and disorganization that threatens many natural wonders in Iceland. Parts of the geyser area have been destroyed, large areas have been trodden down and ropes used for path demarcation are much too close to the eyes of the geysers.

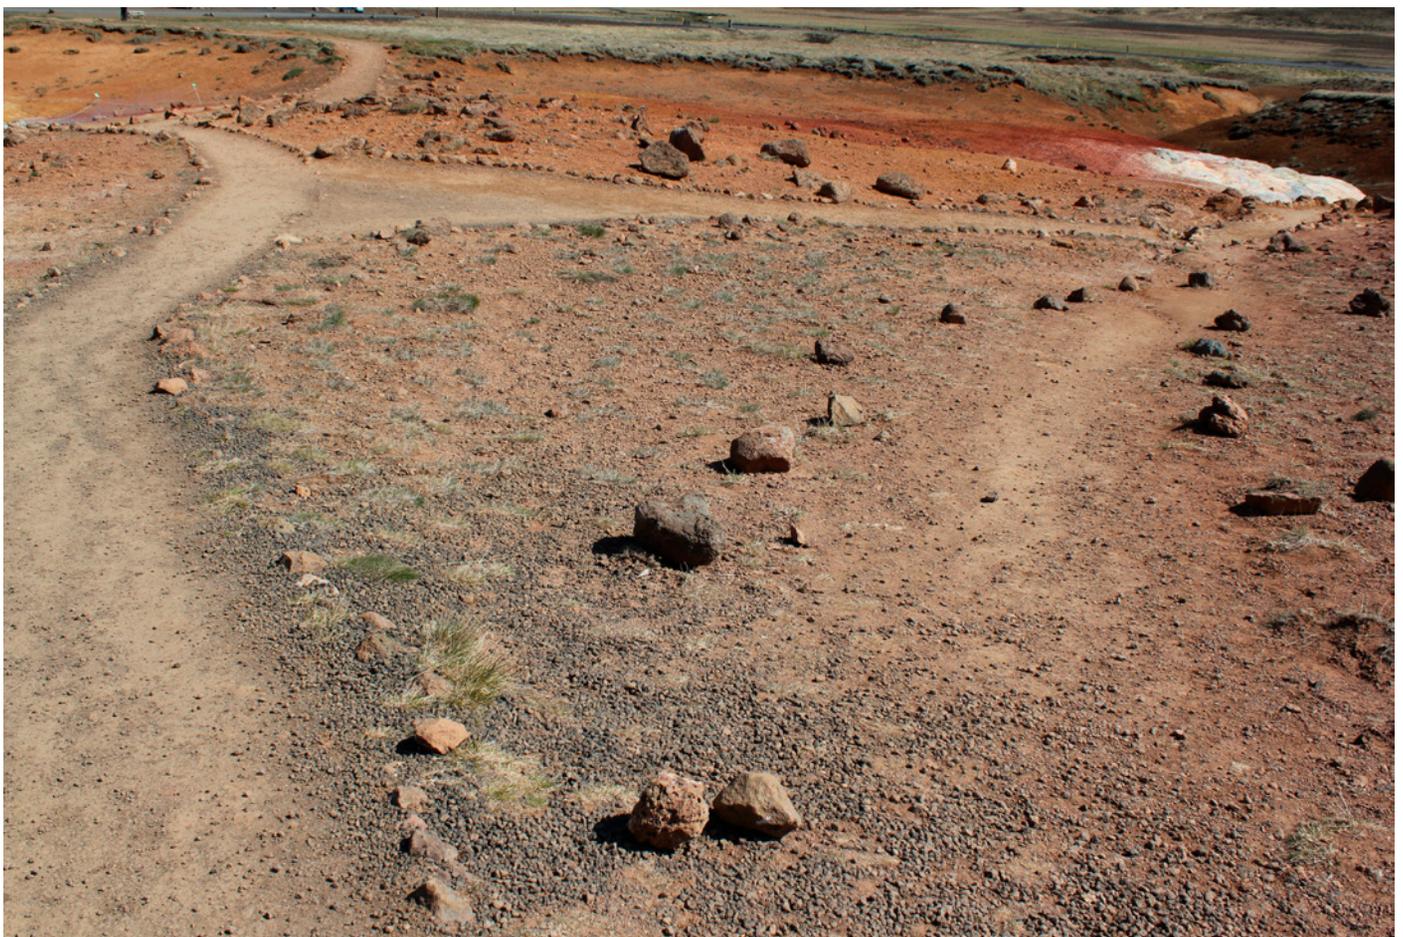
Where to walk?

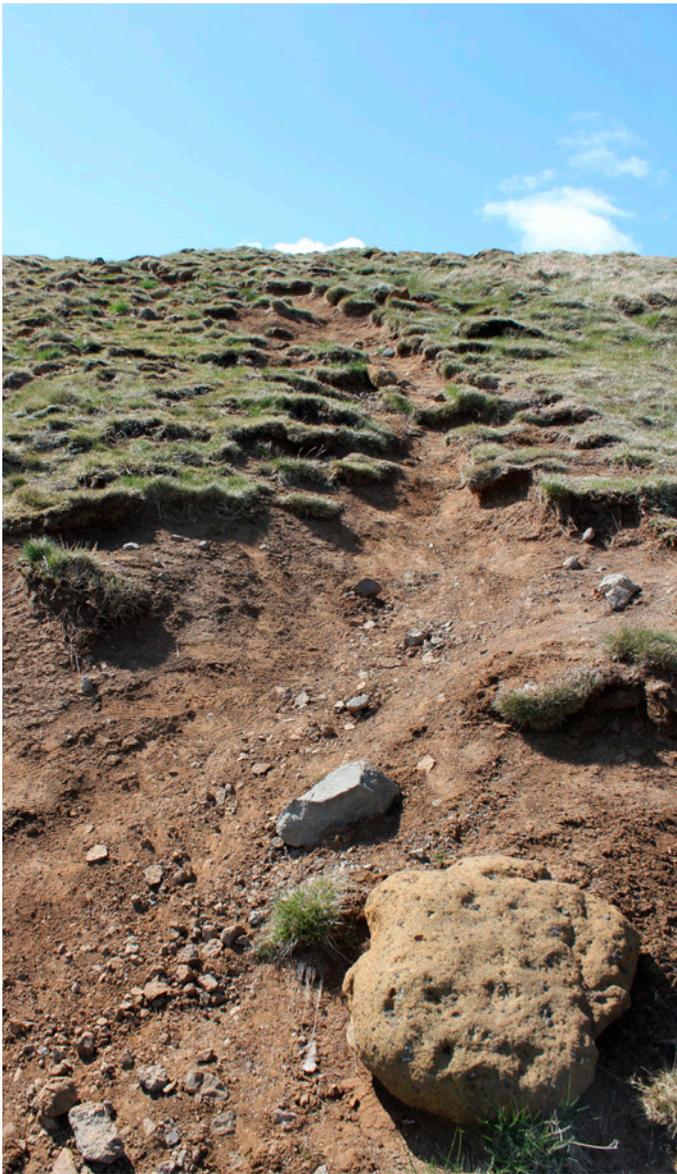
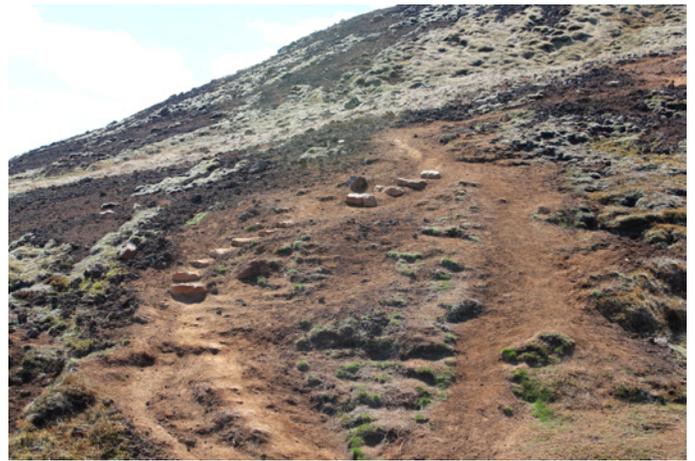
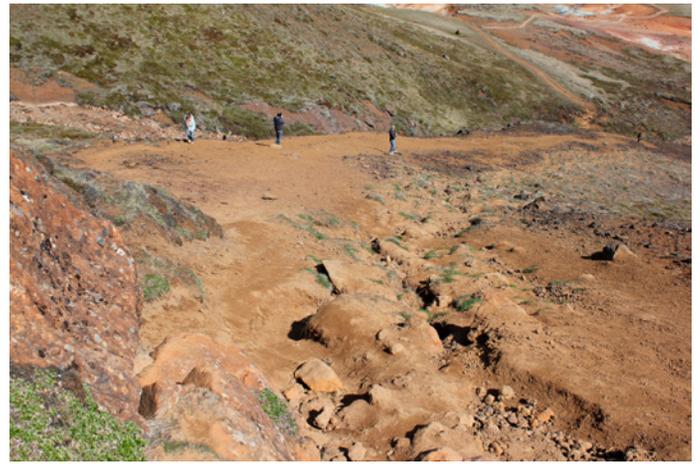
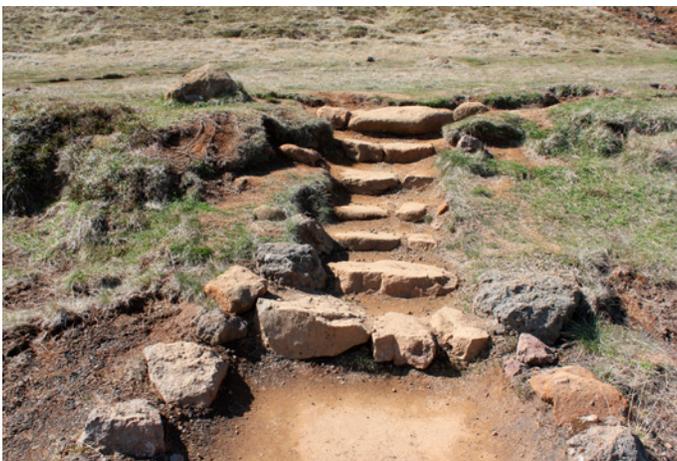
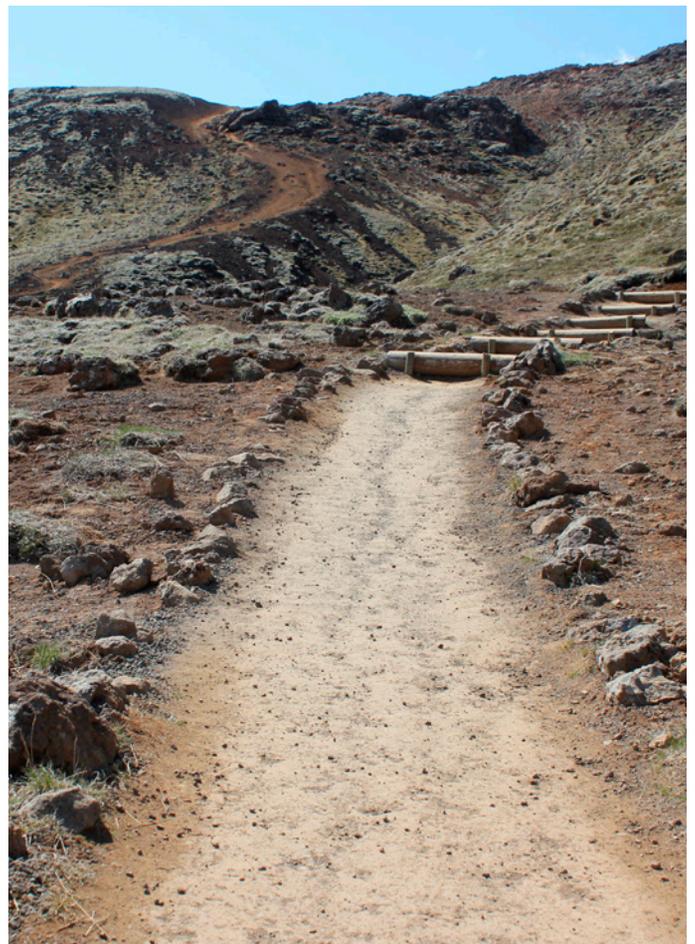
This, or worse, will be the fate of a large part of the pathway system if necessary action is not taken. Deep channels are being eroded by water and there is a danger of new paths being formed alongside the current ones. The first step is to divert all water from the pathways. All such measures will become increasingly expensive as damage proceeds.

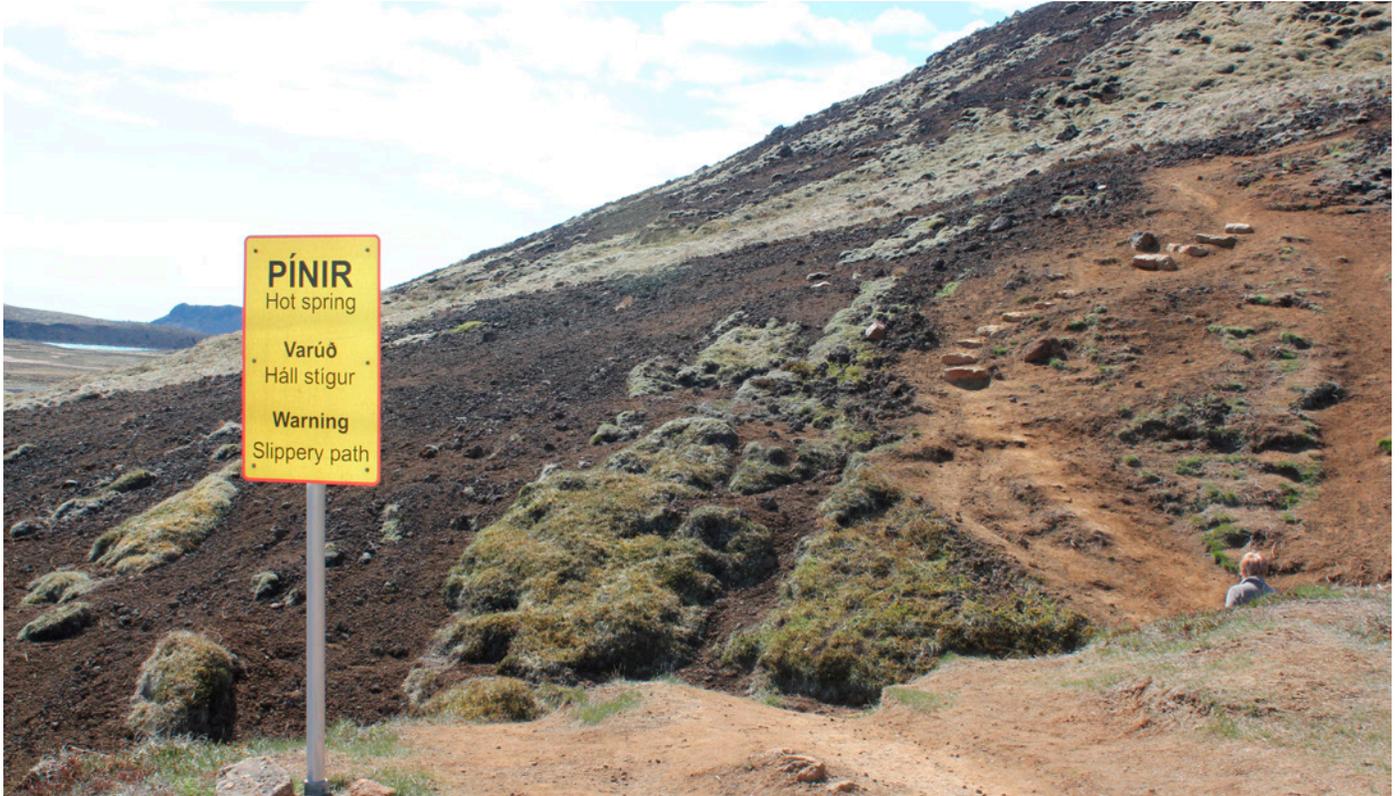
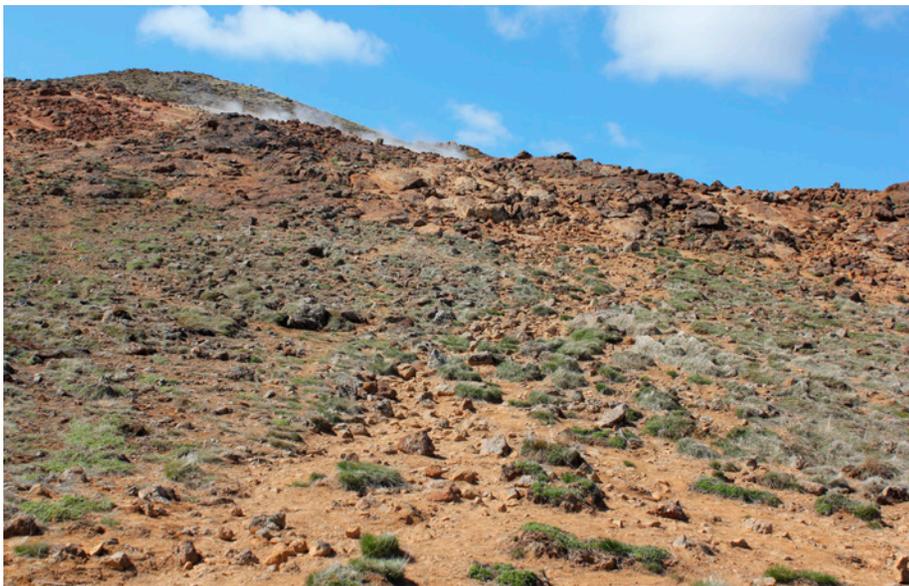
The higher you get inside the geothermal area, the more notable the damage becomes. Downtrodden areas and an out-of-control formation of paths cause damage to an ever-increasing area.

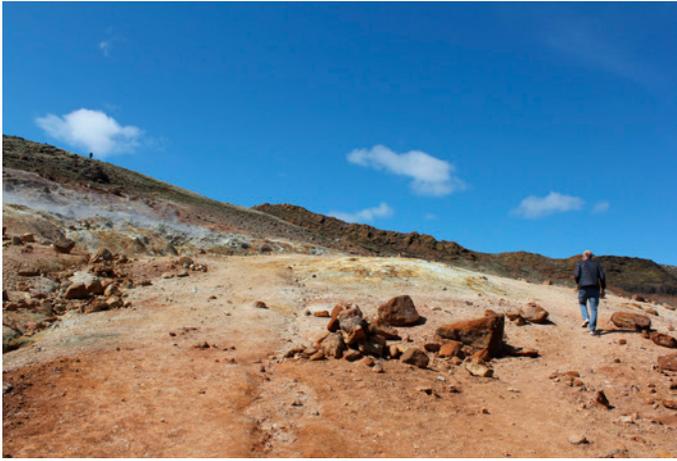
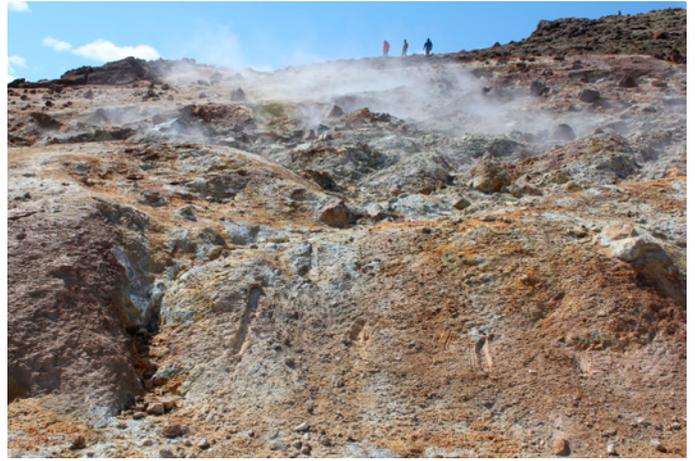
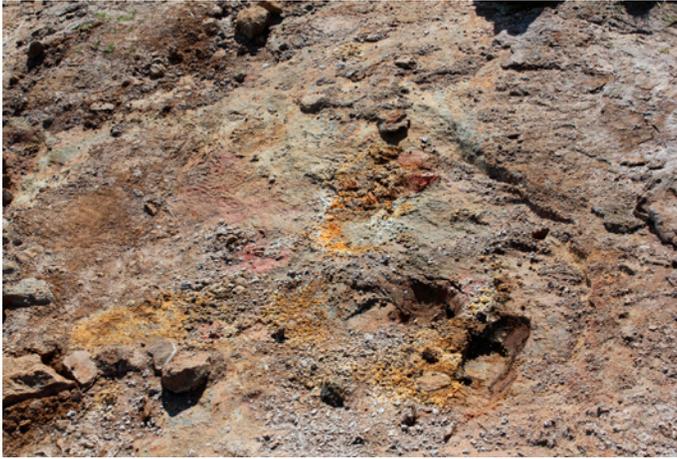
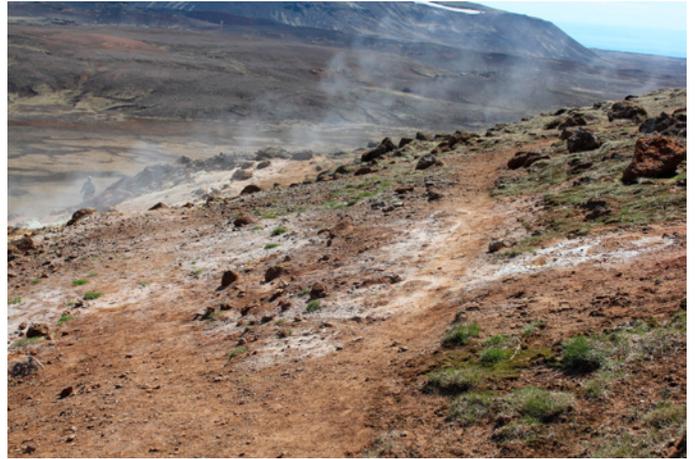
The geothermal areas need to be fenced off from the pathways. These areas are immensely sensitive and already downtrodden and extensively damaged. All traffic into the sensitive areas needs to be prevented. Protecting such areas should be a fundamental prerequisite, before increased traffic is directed at them by constructing paths.

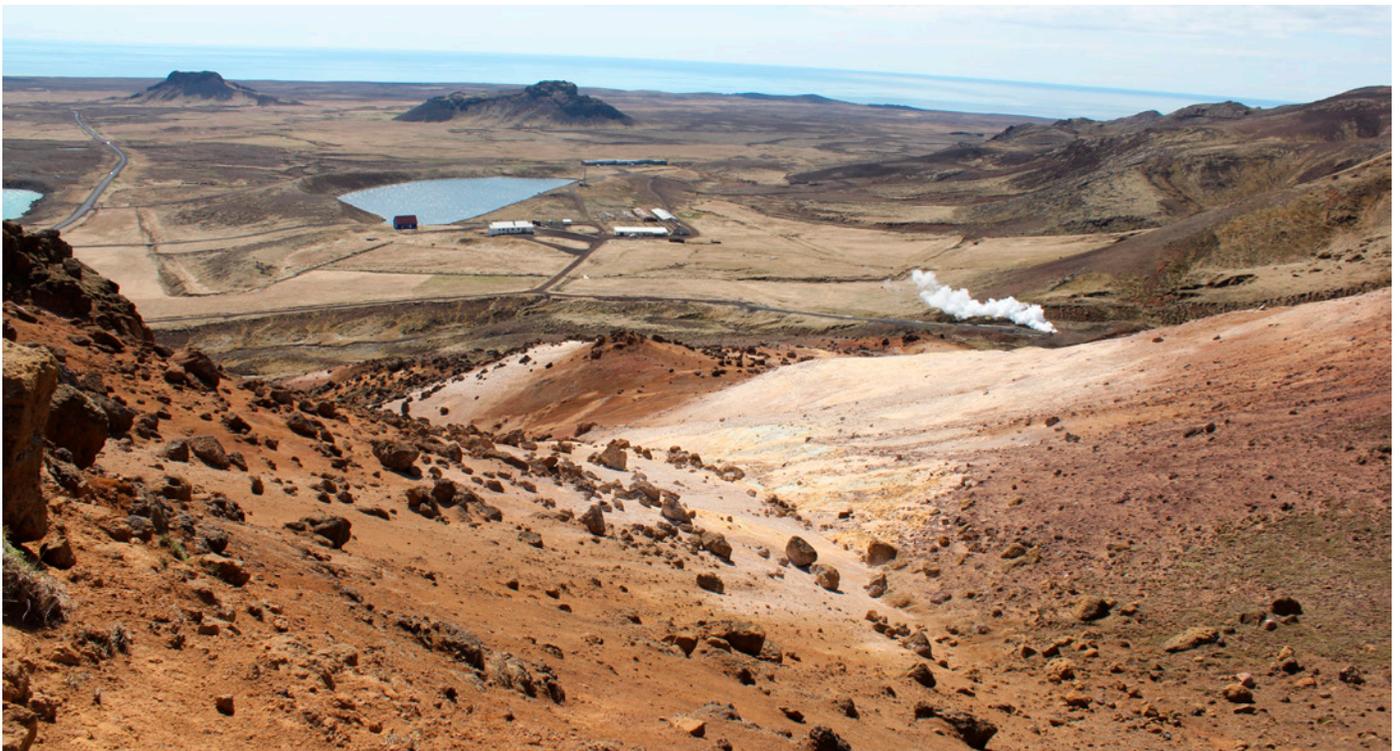
The higher one ventures, the damage due to overload diminishes somewhat. However the damage becomes more evident every year. The fringes are being downtrodden, the geothermal crust is crumbling and the damage areas are growing. Foot-trails can be seen into some sensitive areas, tempting others to follow. Walking paths are forming randomly down to the boreholes at Krýsuvík. Demarcations or words of warning are nowhere to be seen.

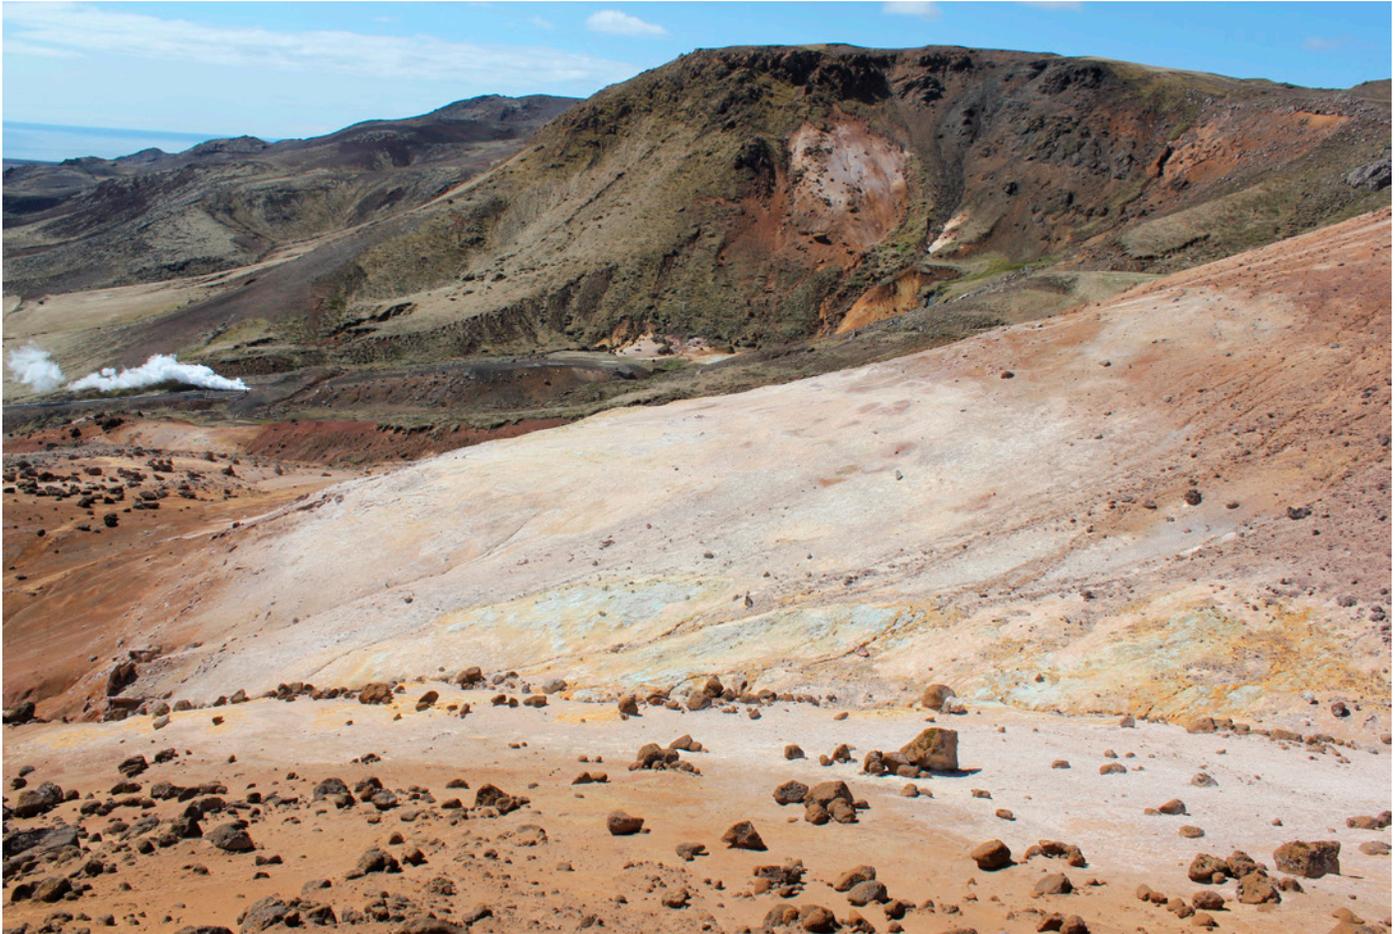
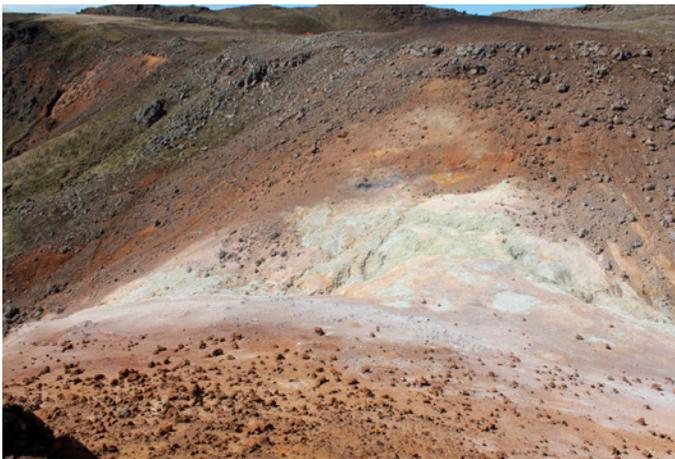
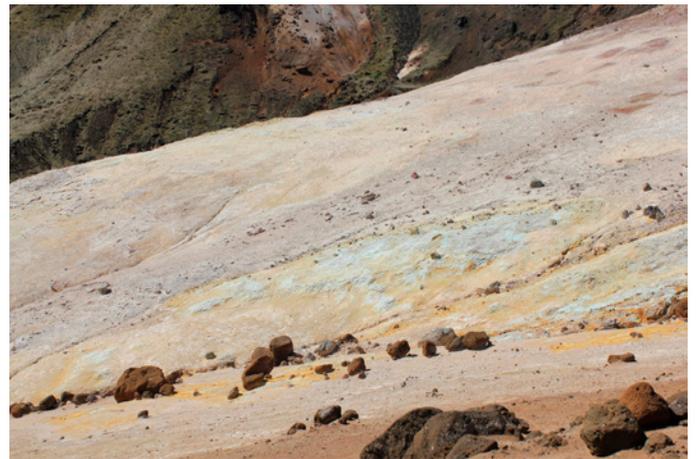
The highest geothermal areas within walking distance of the main area at Seltún are an icon of the pristine beauty that was typical for the area before it was damaged by increased foot traffic. The wide range of colours flourishes and changes with the light. However, nothing is being done to protect this remnant beauty. How accessible should such areas really be made?
